Tlingit Readers, Inc. - Preservation of Historical and Cultural Landmark

National Historic Landmark
Technical Assistance Program

TABLE OF CONTENTS

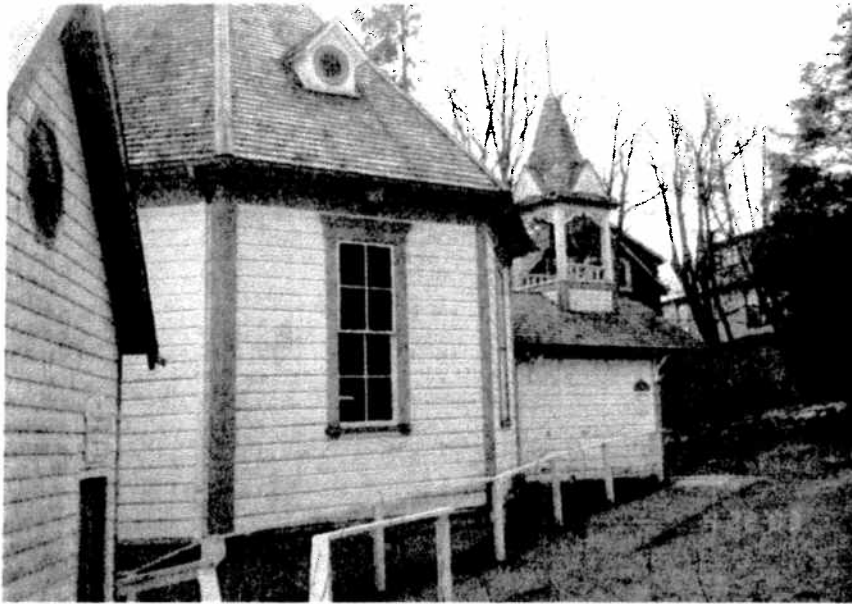
right: Excessive moisture caused by splashback from the main roof drip edge is evident at the intersection of the entry roof and nave wall.

The exterior wall surface and the wall assembly appear to be in good condition. The building seems to be sitting level and plumb with no noticeable deformation or failure. The exterior siding at the narthex north elevation shows signs of damage due to splash-back from uncontrolled roof runoff. Typically, damage in historic building can be expected in areas of ground contact and beneath window sills or horizontal penetrations of the exterior skins. The church is in need of painting.

1. Control ground splash-back; replace deteriorated siding with new to match.
2. Repaint the exterior of the building. Investigate to determine the condition of wall framing beneath the windows and corners.
3. Evaluate the wall assembly and determine the need for insulation.

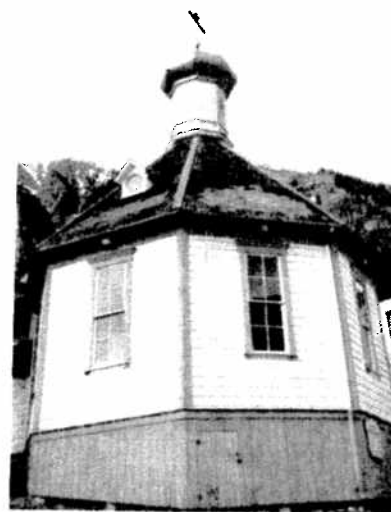
The window sash and trim remain in fair condition and are in need of refinishing. The double hung windows at the southeast and east walls have rotten lower sashes and sills. The dormer windows were not inspected, however their condition seems to match those of the lower double hung window units.

South elevation, St. Nicholas Orthodox Church.

1. Restore all of the existing windows. Inspect to determine condition of wood members, window putty, paint and condition of wood sill and jamb members. Restoration will require careful removal, stripping of multiple layers of paint, repair and/or replacement of deteriorated window members, reglazing and repainting. Inspect each window sill to determine condition of window casing and wall structure below sills.

Repaint and reinstall all window units. Carefully modify windows to improve weather sealing. Explore use of secondary storm window units to improve thermal performance and weather proofing.

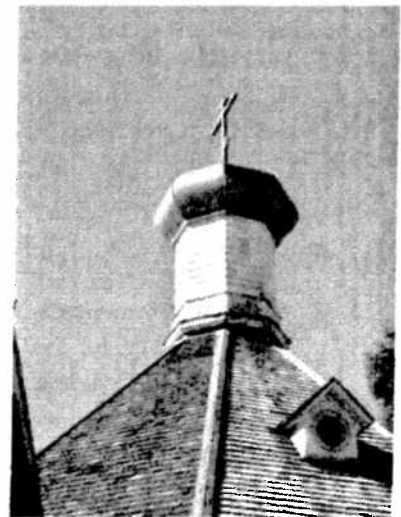
A single onion domed cupola sits atop the pyramidal roof of the church.

The cedar shingle roof is in poor condition. The shingles are unpainted and are severely deteriorated and are beginning to fall out as the wood or fasteners fail and the surface is buffeted in wind. Visual assessment of the cupola from the ground reveals no apparent damage or deterioration on the dome, but the wood shingle clad drum below is losing its painted finish. The wood trim at the base of the drum appear to be deteriorating. The drum or the attachment point of the cross to the dome is the probable source of leakage into the building (right over the center of the Nave area). The belfry element over the Narthex is in fair condition, but the main cross mounted on the peak of its shingle roof has lost all of its arms and should be replaced. It appears the adjacent tree branches are contributing dampness and branch damage at that side of the building.

1. Replace the existing sawn shingle roof. Investigate to determine if the original roof was painted. Historically many of the orthodox church roofs were painted or stained. Restore the roof to match the historic color, shingle pattern, ridge trim and type of shingle. Replace all metal flashing with lead coated copper tern metal. Supplement with waterproof membrane products to secondarily protect the building. Remove the tree located to the southeast of the entrance. Restore the wood trim at the base of the drum. Investigate and replace the existing wood crosses to insure a water tight penetration of the roof structure. Repair the drum, dome and belfry to restore deteriorated wood siding and framing

- members. Flash and repair sufficiently to halt any water penetrations. Proper repair could require scaffolding or the removal and repairs of the dome and belfry at a separate location.
2. Replace all existing gutters with wood gutters. Insure that rain leaders move roof runoff away from the building. Modify landscape to facilitate site drainage away from the building.

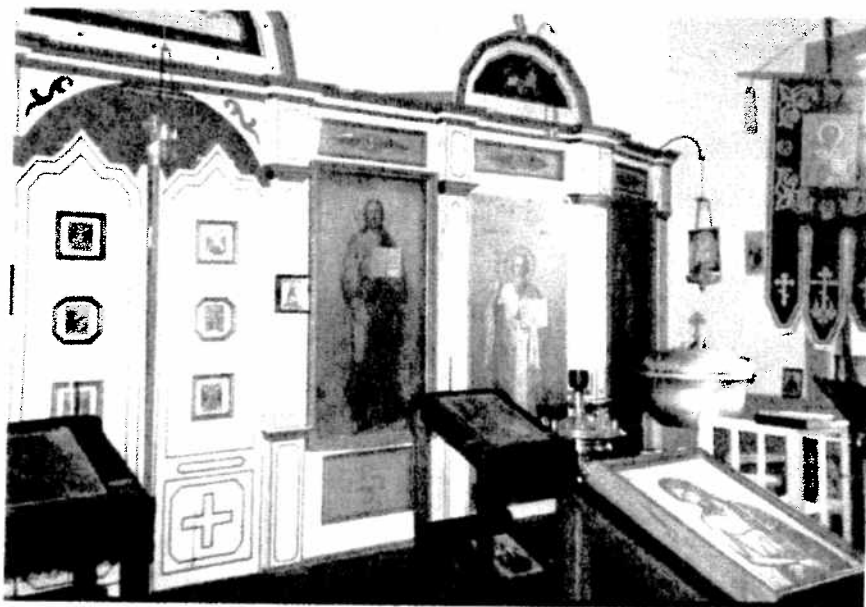
The condition of the icons and historic objects range from poor to fair. Years of little cleaning or conservation care along with an unstable environment are taking their toll on the condition of the artifacts.

The royal doors of the iconostas and icons.

1. Document the 35 icons and historic objects in the church. Proceed with conservation treatment by a qualified conservator. Follow established priorities for preservation. Install a mechanical and fire protection systems to provide a stable environment for their long term preservation.

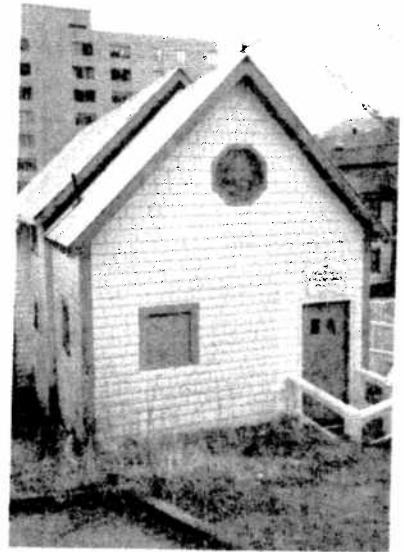
bottom: The recent removal of the chimney from the rectory's east elevation has been patched with cedar shingles.

1. Investigate to determine framing, sheathing and siding condition under the shingle covering. Remove the existing wood shingle and based upon investigation, restore the original wood siding or replace the deteriorated shingle siding. Consider insulating the wall cavities to allow for year around occupancy.
2. Research to determine the original color pallet and restore. Evaluate the significance of the removed chimney and reconstruct if determined that it was a significance historical element. Much of the original soffit, fascia, and window trim detailing have been stripped away with retrofits over the years. These details should be reconstructed based on old photos and similar buildings in the area.
